Title: Phantom Specter Firmware Upgrade Failure

No: Phan22-1

Date: Thursday, 20 September, 2007

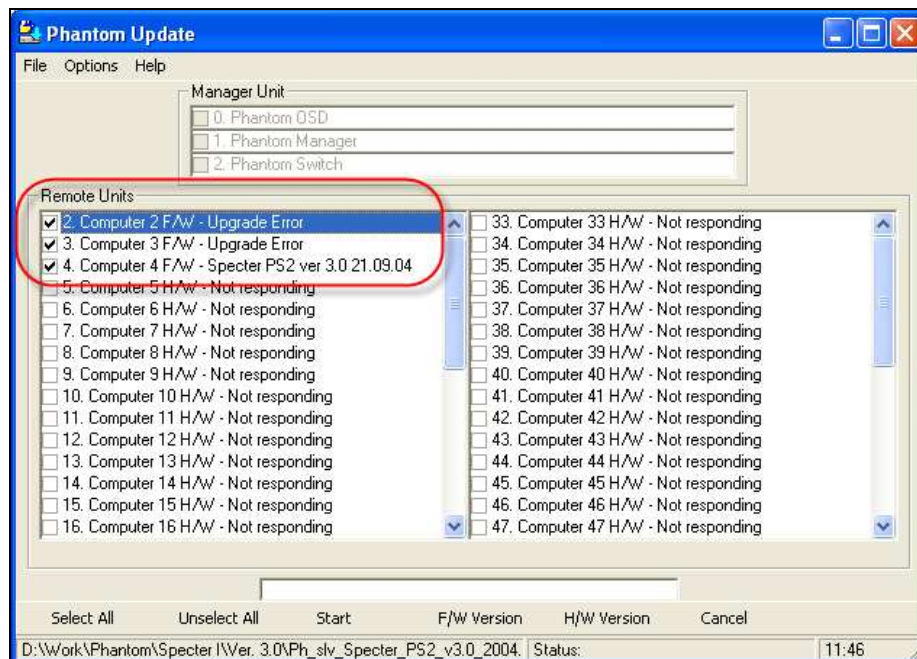
In Phantom Specter I PS/2 (1SU51003) revision 2.7, Phantom Specter II PS/2 (1SU51010) revision 1.9, Phantom Specter II USB (1SU51011) revision 1.6, Phantom Specter II SUN (1SU51009) revision 1.7 and Phantom Specter II RS232 (1SU51012) revision 1.7 the main processor was replaced to a different model. The new processor requires different timing for firmware upgrade.

Using the Phantom Update software version 1.6 or older to upgrade firmware of the Specters will fail with “Upgrade Error” message:

Phantom Specter will stop working and LED Link will remain Off even when the unit connected to the switched on server,

To resolve this firmware upgrade issue, download the new Phantom Update software version 1.7 from the following link:

www.minicom.com/support/phantomupdate1.7.exe or from the Phantom Upgrade web page: www.minicom.com/phandl.htm

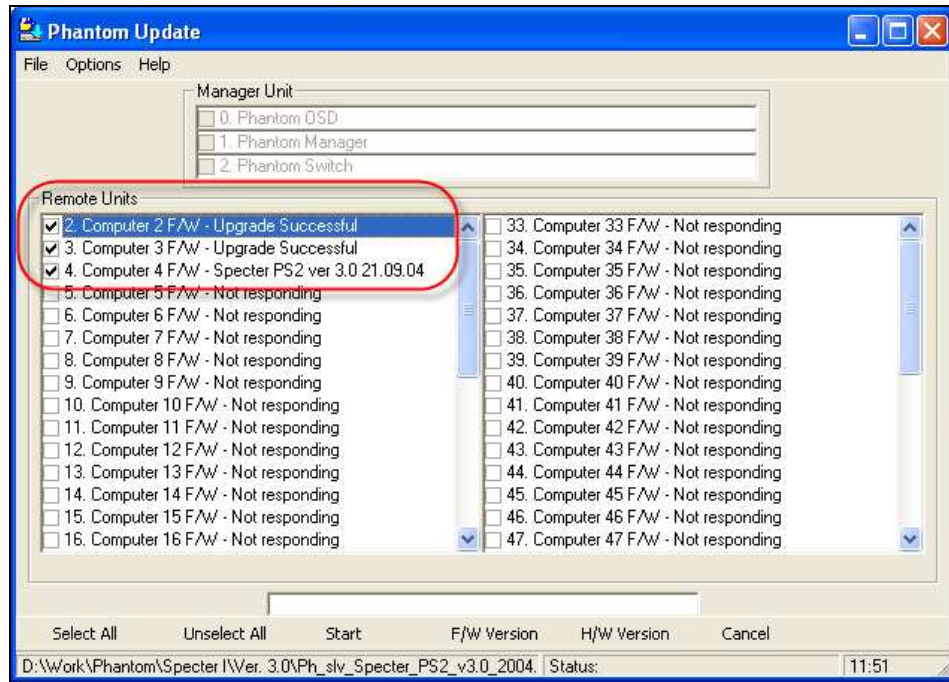
Install the new Phantom Update software version 1.7 on your computer and perform the firmware upgrade of the Phantom Specters. This time the upgrade process will finish successfully:
